Prepared for The City of San Jose

**STABILITY ANALYSIS
FOR LANDSLIDE STABILIZATION
ALUM ROCK AVENUE,
SAN JOSE, CALIFORNIA**

File No.: 44-000276/001
August 15, 2000

**FLAC-FINITE DIFFERENCE
& LIMIT STABILIZATION EQUILIBRIUM STABILITY ANALYSIS
FOR LANDSLIDE STABILIZATION AT THE
ALUM ROCK PARK ENTRANCE, SAN JOSE, CALIFORNIA**

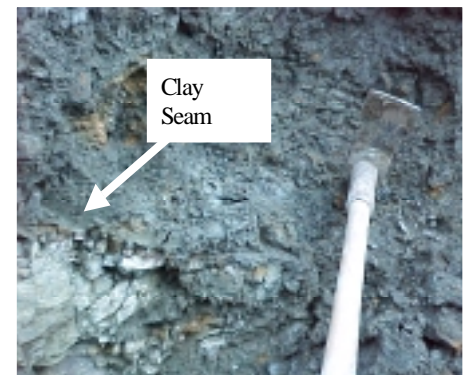
Photo No. 2

During our field observations, a clay seam was located at the toe of the slope on the east side of the slide. The seam overlies a weathered, but competent sandstone bedrock and is overlain by landslide deposits. It is approximately 2 inches thick and is a highly plastic soil with a cohesive strength of 550, to 650 pounds per square foot as measured with a Torvane. The seam dips to the west and is projected to extend below the creek near the centerline of the slide. It was found in three locations from east to west across the toe of the slope. The adjacent photograph shows the clay seam over sandstone. The seam is also located on our cross sections shown on Plates 1B, 22, 23, and 24. Based on our field observations, and on the boring logs provided for this project, we assumed that the failure plane was located in the clay gouge material located at various elevations in the highly fractured rock slope. The clay seam was used to locate the bottom of the slide plane for the stability analysis and establish the shear strength along the slide plane.

Clay Seam Observed at Toe of Slope
